**BOARD OF DIRECTORS  
SPECIAL SESSION  
AGENDA**

# LIFT STATION CONDITION ASSESSMENTS

## Lift Station Condition Assessment Report

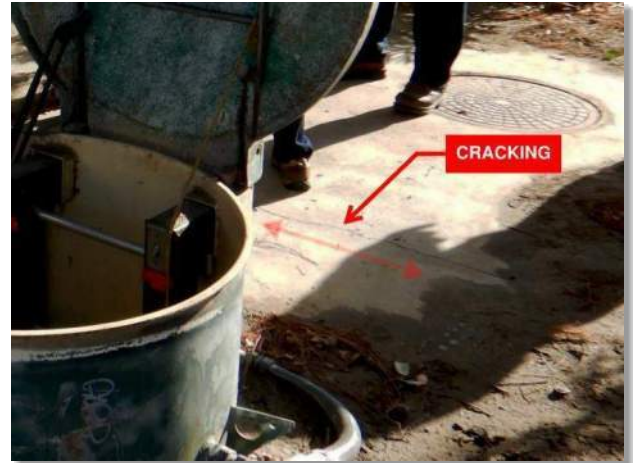
Photo 3-2. Cracking on exterior slab, facing east

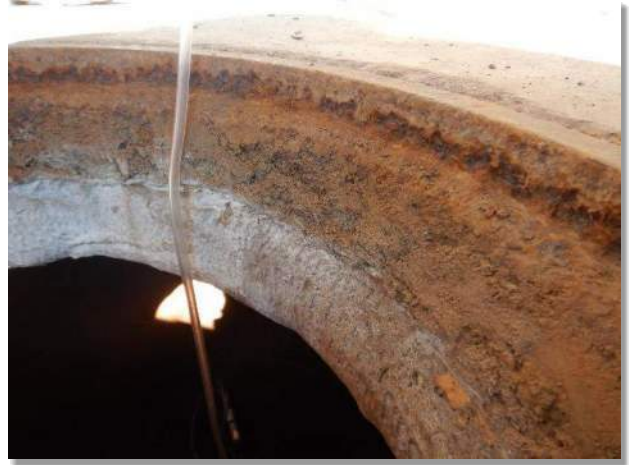
The frame for the wet well access cover was found to be severely corroded. According to Valley Sanitary operations staff, the manhole lid is close to falling in to the structure due to the metal loss of the rim (VANDA 4). The epoxy liner begins approximately 4-ft above the floor of the wet well and was found to be in fair overall condition with blistering (2-in in height) near the lower termination point of the wet well at approximate EL = 486-ft. There were also blisters at two locations approximately 6"x6" in area and located 4-ft below the rim in the east and west quadrants. Refer to Photo 3-15 through Photo 3-22 below.

Photo 3-16. Severe corrosion & metal loss at the rim

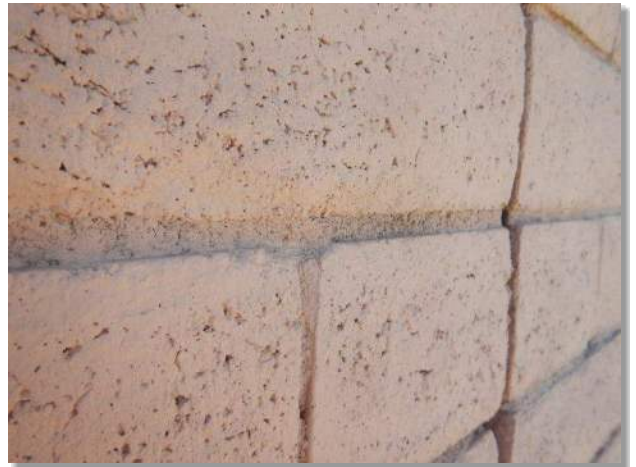
Photo 3-26. CMU mortar pointing in good condition

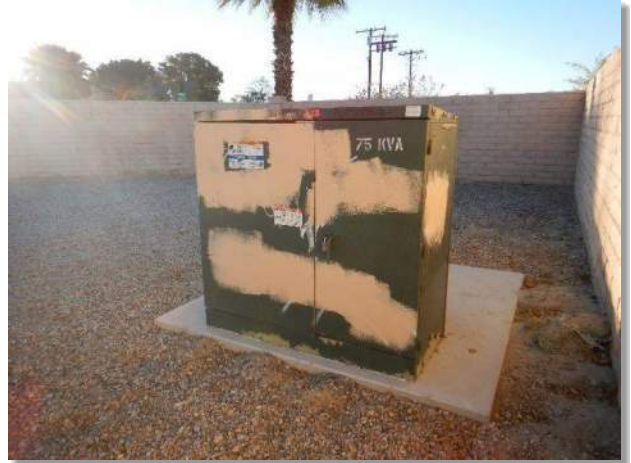
Photo 3-30. Coating deterioration at pad-mounted transformer

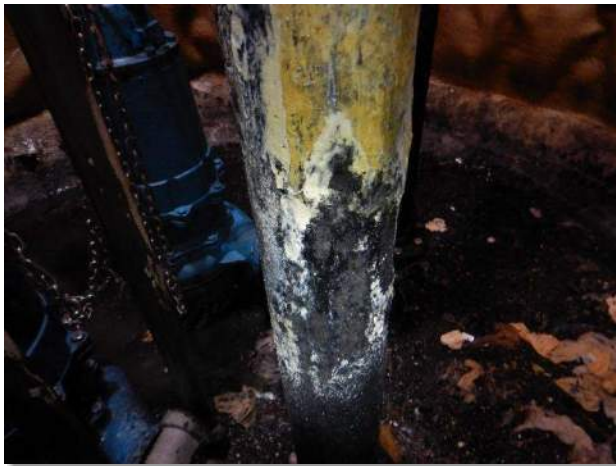
Photo 3-45. Moderate corrosion between 5-ft to 6-ft level of the wet well, typical both discharge pipes

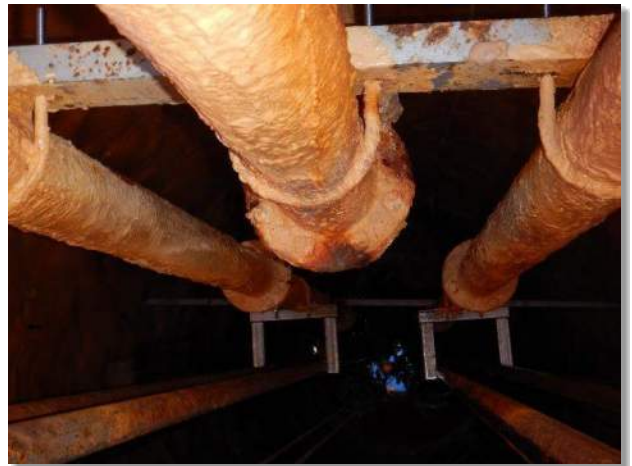
Photo 3-46. Corrosion staining evident throughout discharge piping

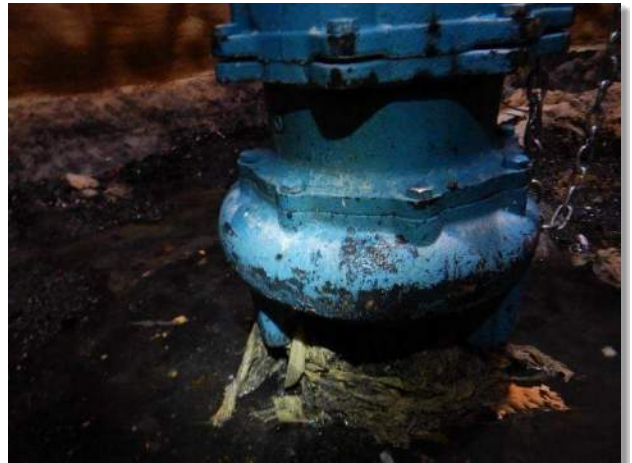
*Photo 3-52. Pump base in good condition, typical*

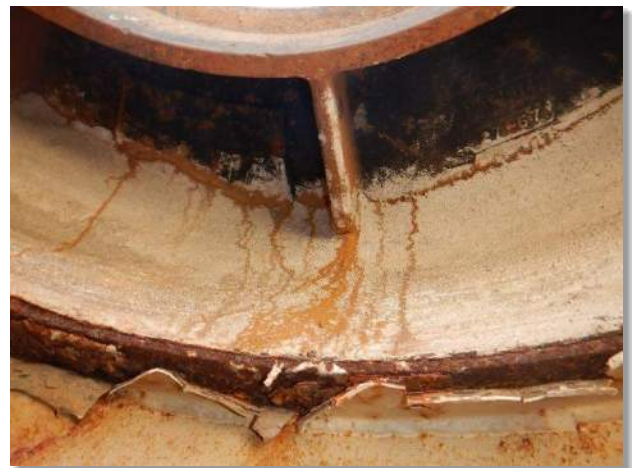
The framing for access into the dry well has a minor offset and moderate corrosion where the interior lining has delaminated (VANDA 3). The ladder entry system was found to have moderate corrosion at the interface with the dry well wall (VANDA 3). The pumps, motors, suction piping, and discharge piping within the dry well exhibited minor surface corrosion throughout (VANDA 2). The interior walls and ceiling of the dry well were found to have minor, localized corrosion where the coating has delaminated (VANDA 2). Moderate corrosion was observed throughout the floor plate with corrosion pits up to 0.150-inch, as well as at the sump and sump pump (VANDA 3). Refer to Photo 3-53 through Photo 3-70 below.

Photo 3-56. Moderate corrosion on framing where coating has delaminated

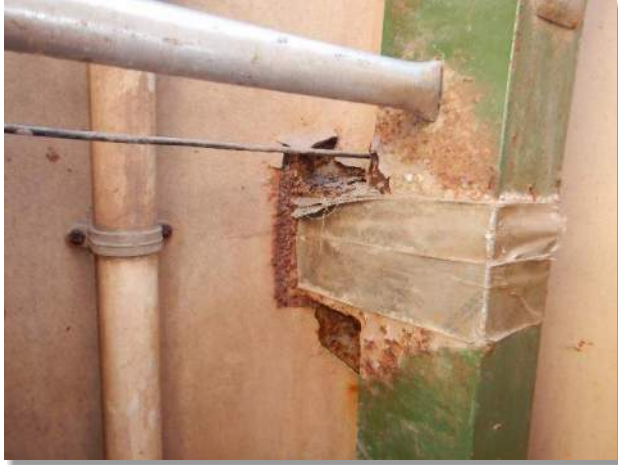
Photo 3-57. Moderate corrosion at ladder entry system interface with wall

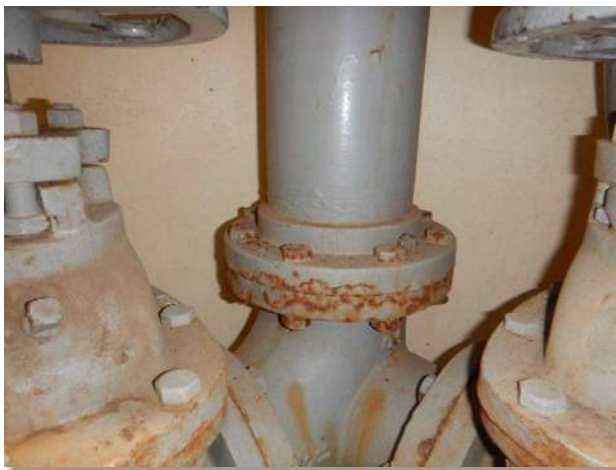
Photo 3-67. Discharge header, minor corrosion at flange

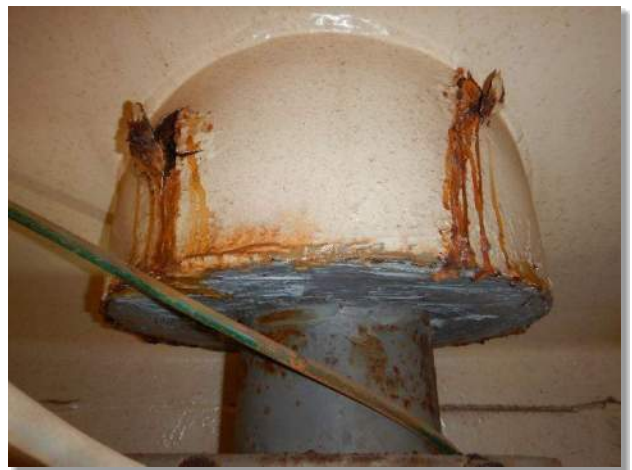
Photo 3-68. Discharge header, minor corrosion at ceiling penetration

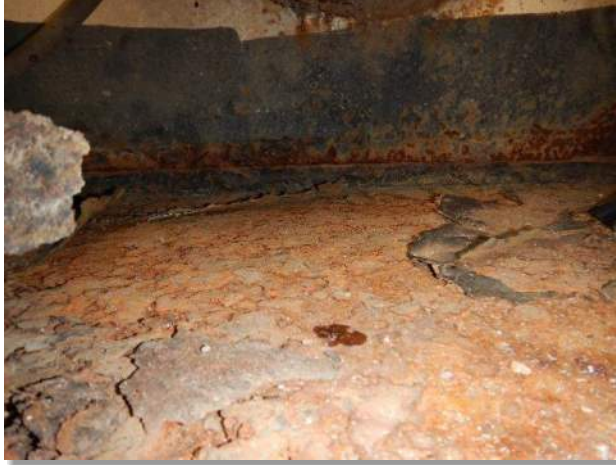
Photo 3-69. Moderate corrosion at floor plate

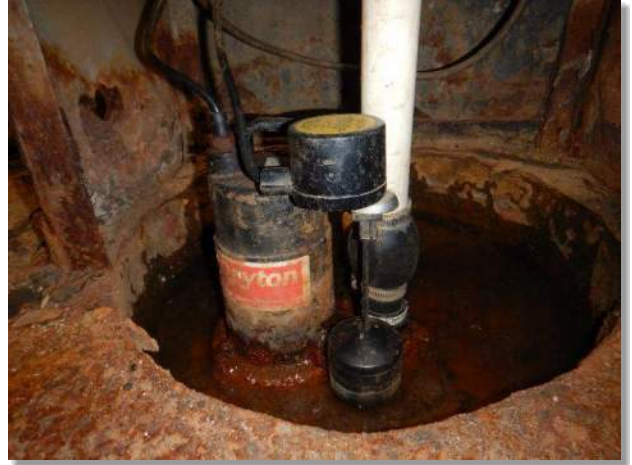
Photo 3-70. Moderate corrosion at sump

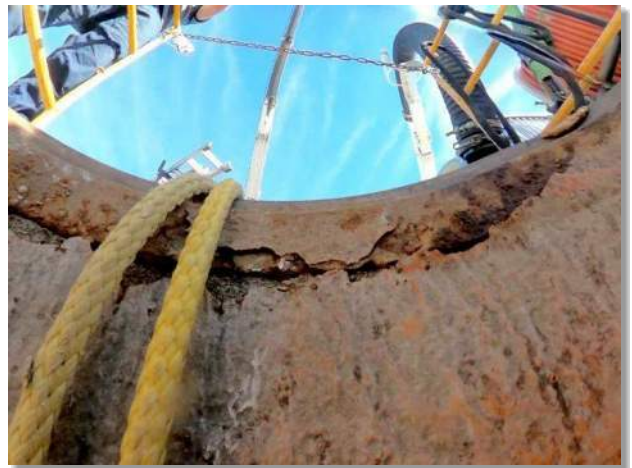
The framing for access into the wet well exhibited moderate corrosion where the lining has deteriorated (VANDA 3). Otherwise, the interior lining was in good overall condition above the waterline, however, the liner beneath the laterals was torn and retaining water in multiple locations. Refer to Photo 3-71 through Photo 3-76 below.

Photo 3-72. Moderate corrosion at rim where lining has deteriorated

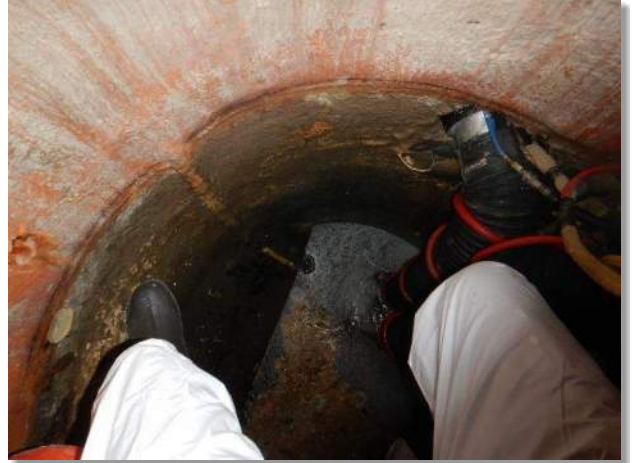
*Photo 3-74. Wet well interior, liner degraded below waterline*

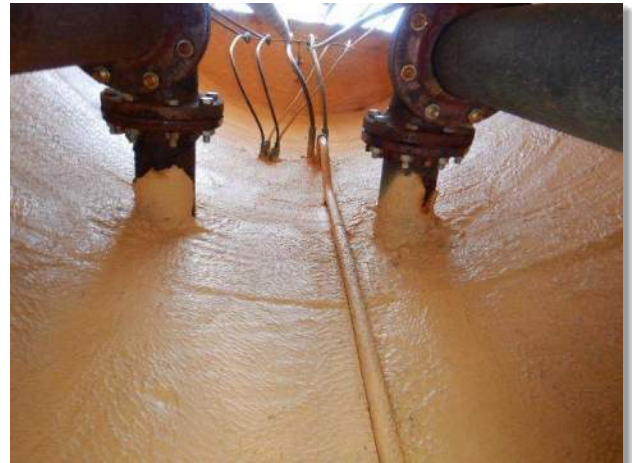
Photo 3-88. Pump discharge piping wall penetration, wet well interior lining in good condition.

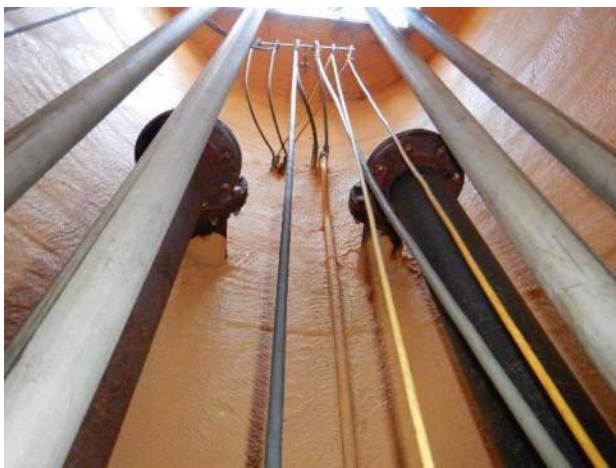
Photo 3-89. SST guide rails in good overall condition

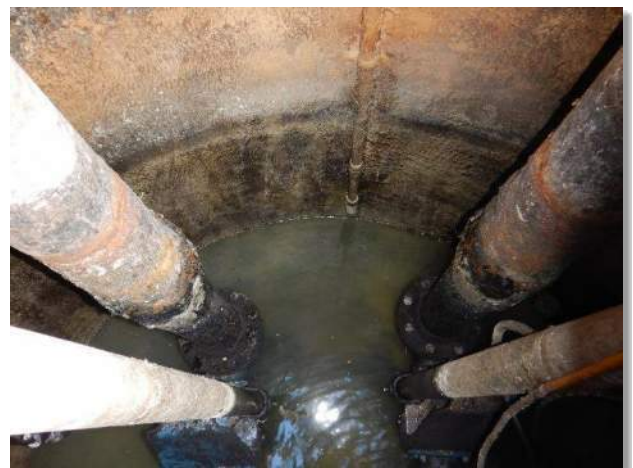
Photo 3-90. Severe corrosion of DIP discharge piping at operating level

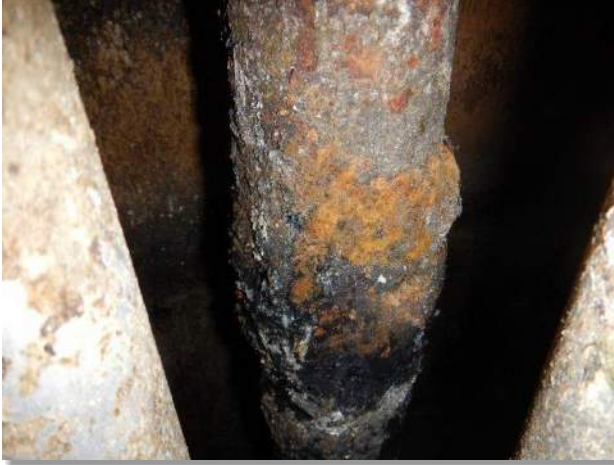
*Photo 3-91. Severe corrosion at Pump 1 discharge piping, close-up*

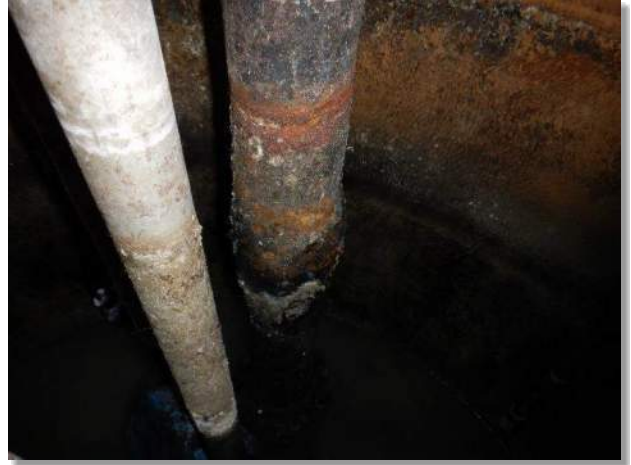
*Photo 3-92. Severe corrosion at Pump 2 discharge piping*

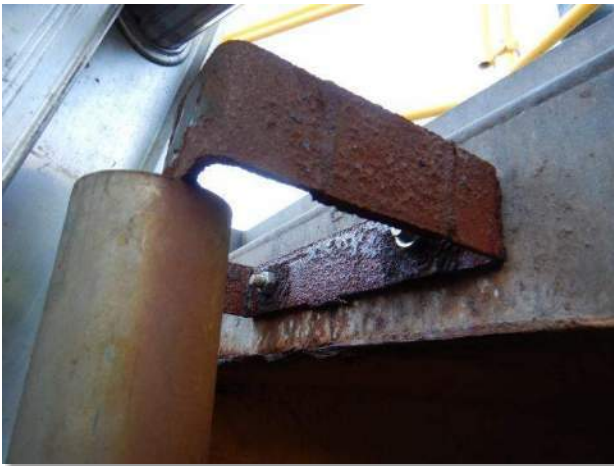
*Photo 3-93. Moderate corrosion at mild steel supports*

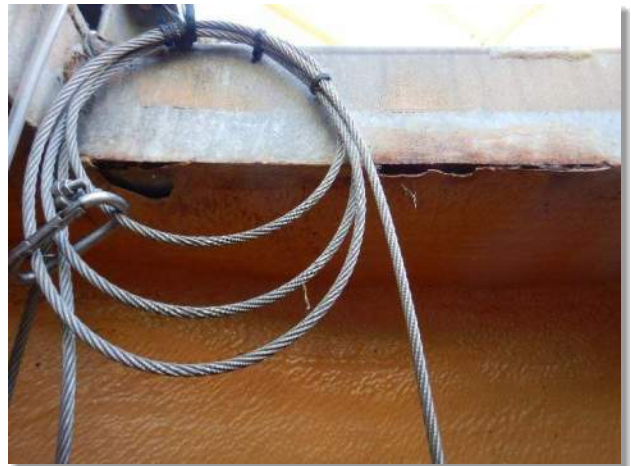
*Photo 3-94. Minor delamination of liner at the ceiling*
