Operations Committee Meeting
Tuesday, June 7, 2022 at 1:00 PM
Valley Sanitary District Board Room
45-500 Van Buren Street, Indio, CA 92201

TO: Operations Committee
FROM: Ron Buchwald, Engineering Services Manager
SUBJECT: Lift Station Condition Assessment Report Review

LIFT STATION CONDITION ASSESSMENTS

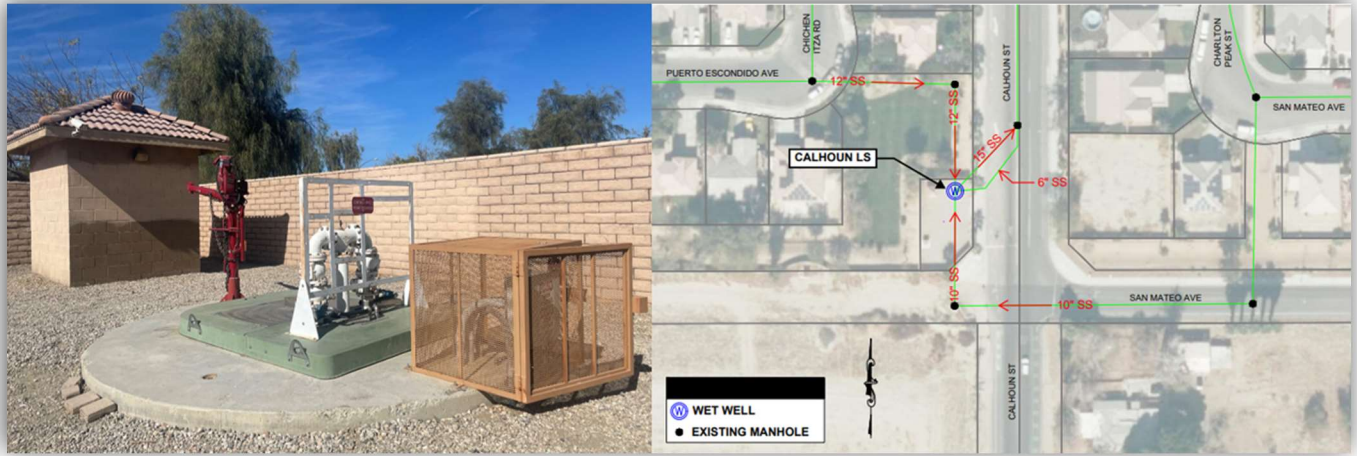
FIGURE 2: Calhoun Lift Station Schematic and Site Photo

The Calhoun lift station, built in 2005, is a submersible style lift station with an approximate 13-foot diameter precast concrete manhole and a 5-foot x 3-foot access hatch (Figure 2). The station is located within a residential

The wet well collects flow from two incoming sewer mains and is then pumped through a 4-inch force main to a manhole in Calhoun Street. Provided drawings showed a 6-inch force main; however, from the site visits the visible piping was 4-inch. The station has two submersible pumps, each with a design capacity of 630 gpm and are operated in a duty/standby configuration. The wet well has a 15-inch PVC emergency overflow as shown on the drawings. The piping configuration is shown in Figure 2.

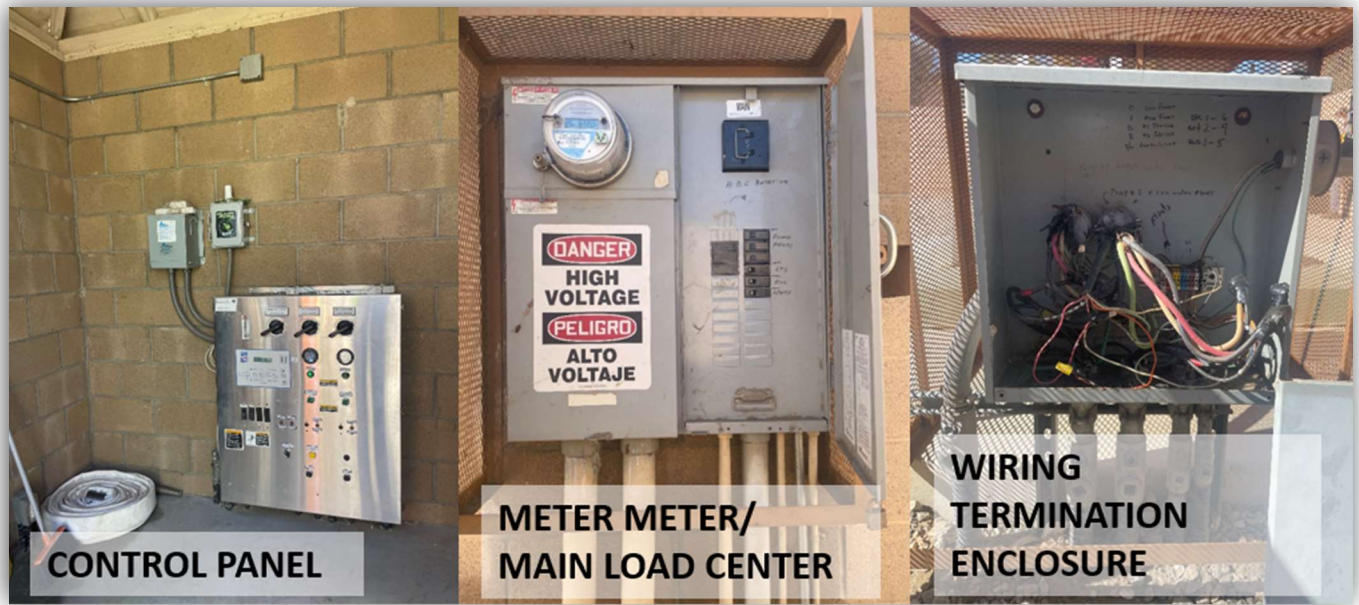
FIGURE 3: Calhoun Lift Station Photos

The lift station equipment is fed from a 208 Volt, 3-phase control panel powered from a combination load center which is rated 200A, 208V, 3-phase fed from a 75kVA Imperial Irrigation District (IID) transformer. The wall-mounted control panel, Gorman-Rupp Pumps EPS 2000 Pump Control Panel, is rated 125A and supplies electrical power to two 10-horsepower (hp) submersible pumps and contains the station controls. The pump control system consists of a bubbler (primary) with float (backup) and a radio alarm autodialer. A 3kVA dry type distribution transformer and alarm autodialer are wall mounted adjacent to the control panel (Figure 3).

Overall, the control panel, transformer, autodialer, electrical wiring, and connections at Calhoun are original installation and are in good working condition. Several items were noted for electrical improvements and upgrades. Station structures are also in overall good condition with minimal deficiencies in structural elements.

The major deficiency observed at the station was with the wet well liner, found to be substantially delaminated in numerous locations, in addition to tears and split seams. Concrete scaling was observed behind the liner.

The existing pumps get pugged often from wipes and other items. VSD has submitted new chopper pumps for this station in their future budget. VSD mentioned that the pump does not seal well on the base elbow. This could be caused from a misaligned rail system, which can be readjusted when the new pumps are installed.

Inside the wet well, the lining and discharge piping need replacement. Both projects should be done with the installation of the new pumps VSD intends to purchase since all will require bypass pumping and will benefit from coordination.

No.	Improvement Recommendations	Estimated Cost, \$ ¹
Construction Projects		
1	Install upgrades to main electrical panel, control panel, and autodialer	\$ 47,500
2	Install new sump termination panel	\$ 27,700
3	Remove existing liner and install full coating of wet well interior surface and install discharge piping with fusion epoxy coated	\$ 266,900
4	New coating on above ground piping	\$ 1,300
5	New coating on pad-mounted transformer enclosure	\$ 1,300
6	Replace interior fixtures with LED and exterior with LED motion-sensor lighting fixtures at electrical building	\$ 6,000
7	Install new SCADA system for remote monitoring and controls capability	\$ 49,500
Total for Items 1-7 (2022 Dollar value)		\$ 400,200
Total (in 2023 dollars)²		\$ 413,600
Total (in 2024 dollars)²		\$ 427,500
Total (in 2025 dollars)²		\$ 441,900
Studies		
8	Perform arc flash study and provide labels	\$ 12,600
9	Perform structural analysis of the CMU control room	\$ 18,900

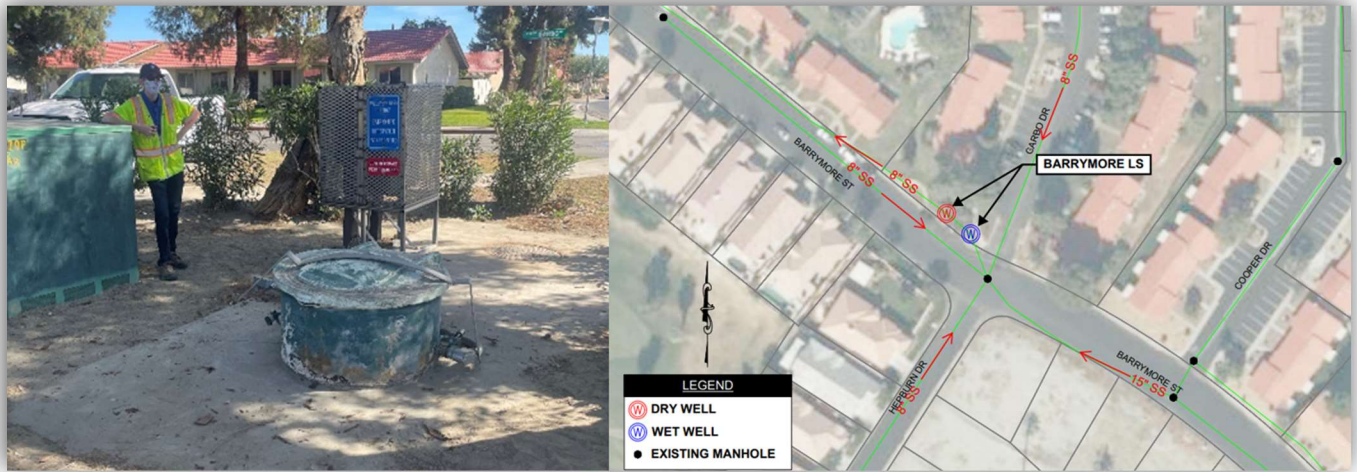
FIGURE 4: Barrymore Lift Station Schematic and Site Photo

The Barrymore lift station, built in 1979, is a pre-packaged Smith & Loveless lift station consisting of a concrete wet well and cylindrical steel dry well (Figure 4). The station is located on an easement within a gated residential

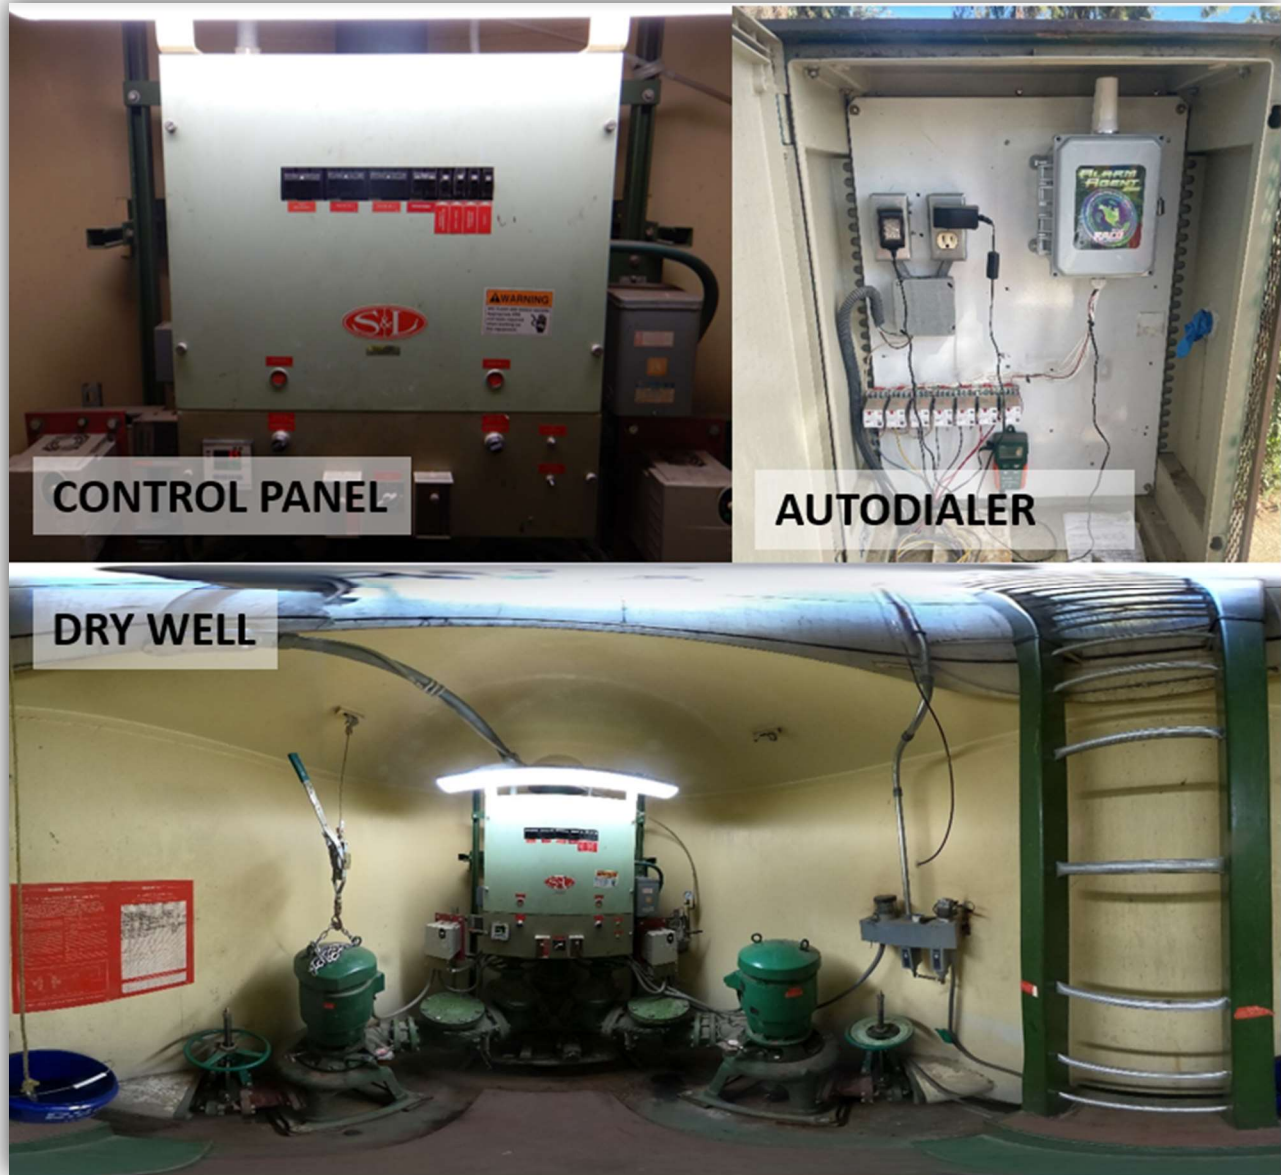
FIGURE 5: Barrymore Lift Station Photos

The lift station equipment is fed from a 240 Volt, 3-phase control panel powered from an Imperial Irrigation District power service. It is equipped with a 100 Amp main circuit breaker that supplies electrical power to two 10-horsepower variable frequency drive-driven pumps, two air compressors, a sump pump, a dehumidifier, a blower, lighting, and station controls (Figure 5).

The Barrymore Lift Station structure is in overall good condition with minor noted deficiencies in structural elements. However, the electrical equipment is clearly outdated and in need of a complete upgrade to ensure system reliability and functionality. It is recommended to relocate the control panel above grade. Deterioration of the wet well liner was observed and is recommended for replacement.

Recommended control panel replacement will maintain all the functionality of the current control strategies. It is recommended to add backup floats for redundancy and to relocate the existing autodialer and other controls wiring in the outdoor panel to the new control panel. It is recommended to relocate the lift station electrical and controls outside of the dry pit to eliminate the requirement for explosion proof gear in the Class I, Div 2 hazardous area. VSD easements should be clearly identified before the design and relocation of the control panel above grade. Concurrently with the control panel upgrade, a sump termination panel is recommended to isolate the electrical equipment terminations from the potentially hazardous atmosphere in the wet well. Per NFPA 820, the wet well and surrounding area is classified as Class I, Div 2 from three feet in all directions from any opening, hatch, or vent, and extends 18 inches above. The sump termination cabinet is a system that simplifies removal of electrical equipment for maintenance when compared to traditional conduit seal fittings. It is recommended that proper signage also be provided as part of this or any lift station upgrade.

No.	Improvement Recommendations	Estimated Cost, \$ ¹
Construction Projects		
1	Install new control panel above-grade	\$ 227,500
2	Install new sump termination panel	\$ 29,700
3	Install pipe covers over entire length of exposed conduits	\$ 2,000
4	Remove and replace access wet well rim and cover; provide protective coating to prevent future deterioration due to H2S exposure	\$ 22,700
5	Remove existing wet well liner and provide full coating of interior surface	\$ 87,000
6	Clean and recoat pitted floor areas, exterior access riser, and interior riser joint in dry well; repair hatch	\$ 22,100
7	Install new SCADA system for remote monitoring and controls	\$ 49,500
8	Replace sump pump	\$ 5,000
Total for Items 1-8 (2022 Dollar value)		\$ 445,500
		Total (in 2023 dollars)²
		\$ 460,500
		Total (in 2024 dollars)²
		\$ 476,000
		Total (in 2025 dollars)²
		\$ 494,000
		Total (in 2026 dollars)²
		\$ 508,500
Studies, Maintenance, and Monitoring

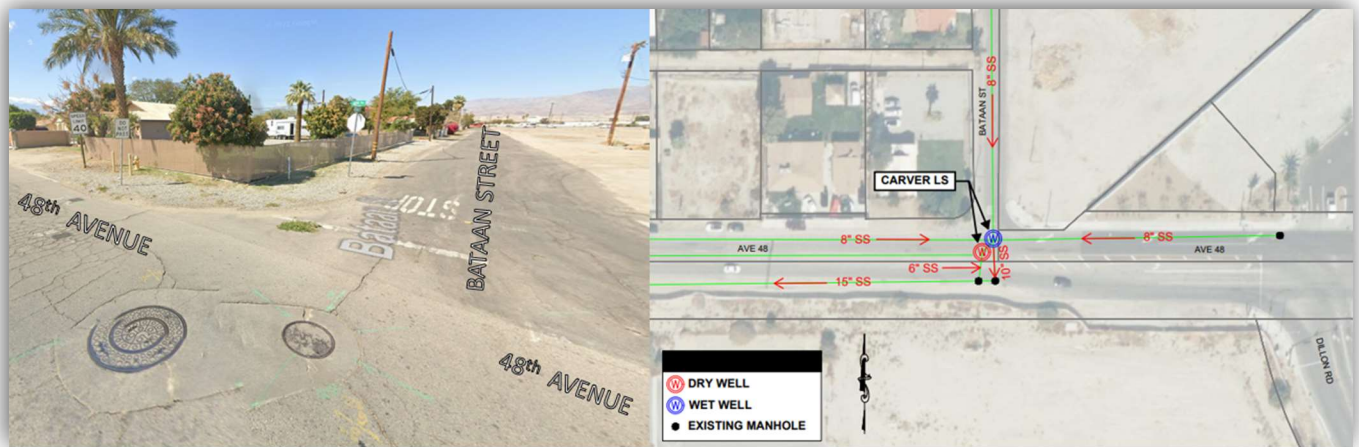
FIGURE 6: Carver Lift Station Schematic and Site Photo

The Carver lift station, built in 1966, is a pre-packaged Smith & Loveless lift station consisting of a concrete wet well and cylindrical steel dry well (Figure 6). The station is located within the westbound travel lane at the intersection of 48th Avenue and Bataan Street in Indio, California. Access to the wells requires partial lane closure and traffic control. Controls equipment is in the dry well.

The wet well collects flow from three incoming mains on 48th Avenue and Bataan Street. Water is then pumped through a 6-inch force main to a manhole south of the dry well in 48th Avenue. The wet well has a 10-inch overflow that leads to a second manhole south of the dry well in 48th Avenue. The piping configuration is shown on Figure 6.

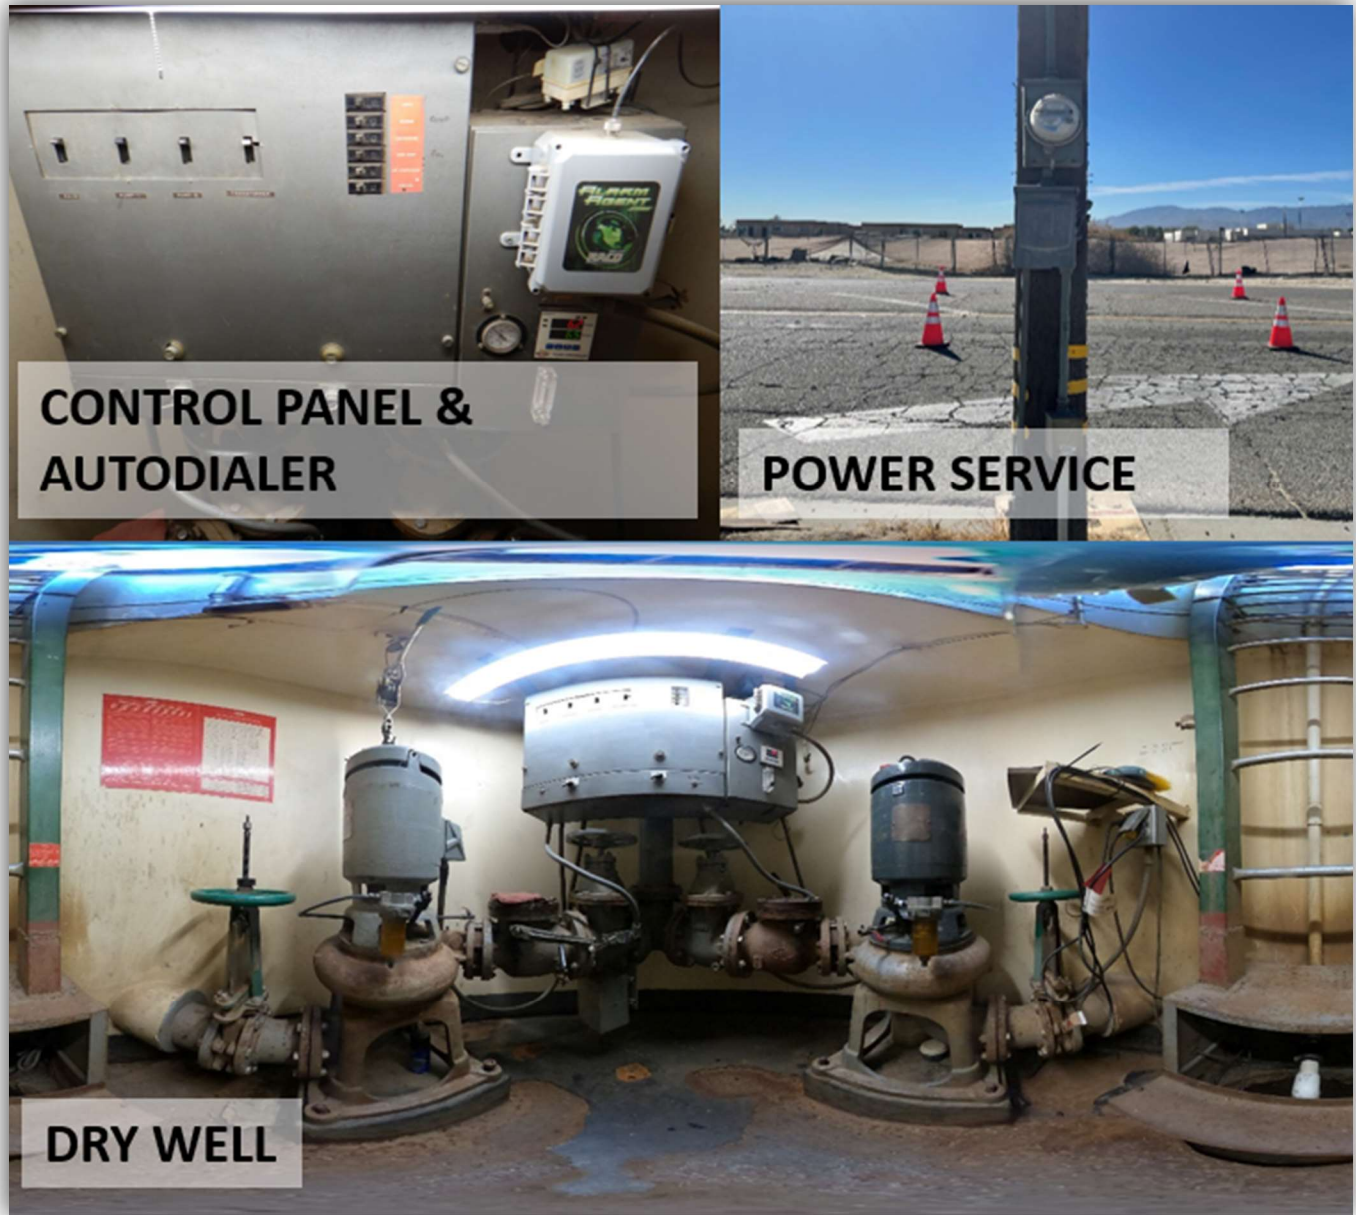
The lift station equipment is fed from a 240 Volt, 3-phase control panel powered from an Imperial Irrigation District (IID) power service. It is equipped with a 100 Amp main circuit breaker that supplies electrical power to two 5-horsepower pumps, an air compressor, a sump pump, a dehumidifier, a blower, lighting, and station controls. The power utility meter and a 50A main disconnect switch are mounted on a pole on a nearby sidewalk (Figure 7).

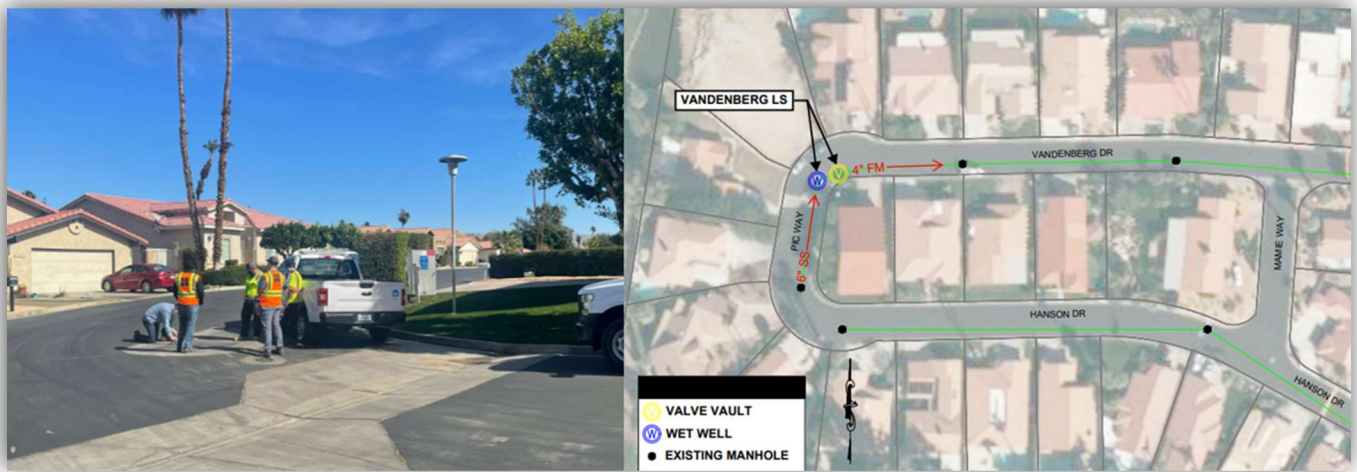
FIGURE 8: Vandenberg Lift Station Schematic and Site Photo

The Vandenberg lift station, built in 2007, is a submersible style lift station with a separate underground valve vault. The station is located within a gated residential community, underground in the center of the intersection of Vandenberg Drive and Pic Way (Figure 8). Access requires light traffic control. The electrical and controls equipment is located on the lawn of a private residence. The control panel is a freestanding single-door type stainless steel NEMA 3R rated enclosure mounted on a concrete pad. The utility power service meter/main pedestal is adjacent to the control panel. A metering pedestal for lighting sits behind the main metering pedestal.

The Vandenberg station serves six houses and operates once a day on average. The station has two submersible pumps, each with a design capacity 110 gpm and are operated in a duty/standby configuration. The wet well has a single 6-inch inlet pipe and pumps flow through a 4-inch PVC force main.

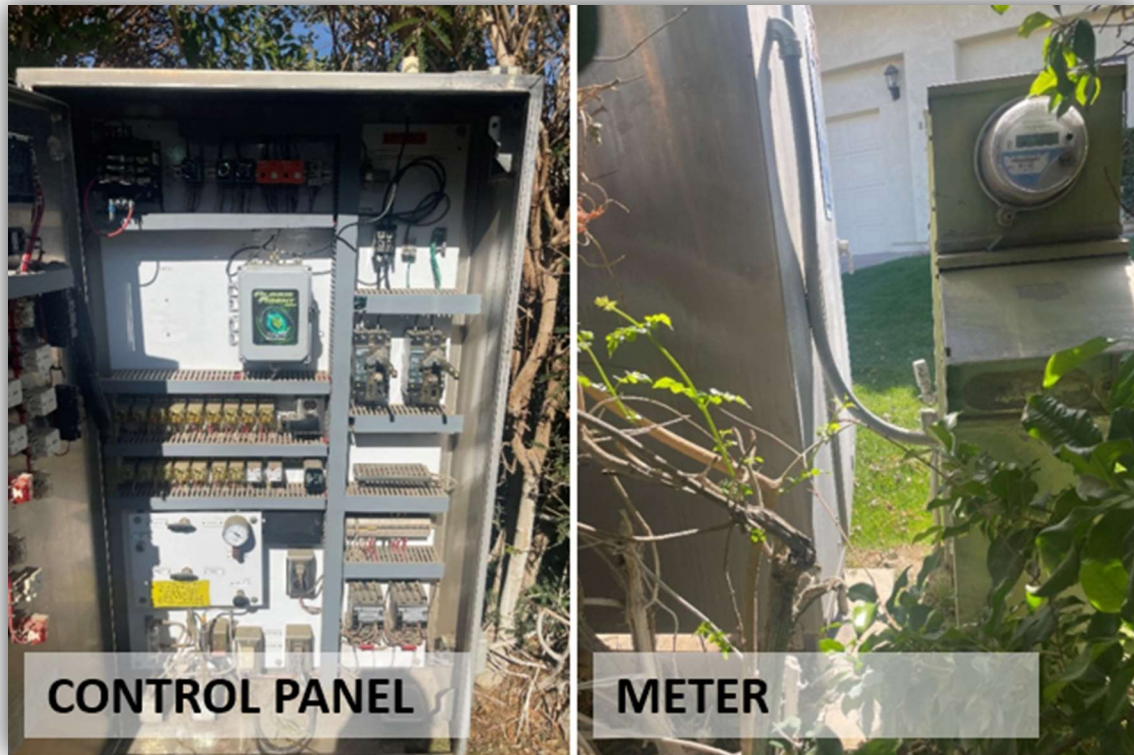
FIGURE 9: Vandenberg Lift Station Photos

The lift station equipment is fed from a 240V, 1-phase control panel powered from a 200A Imperial Irrigation District service. The control panel supplies electrical power to two 2-horsepower submersible pumps and contains the station controls. The pump control system consists of a bubbler (primary) with float (backup), a Mercoid pump controller, and a radio alarm autodialer (Figure 9). VSD finds the controls and redundancy at this station favorable and especially likes the ability to control pump rotation.
