**BOARD OF DIRECTORS  
SPECIAL SESSION  
AGENDA**

# LIFT STATION CONDITION ASSESSMENTS

## Lift Station Condition Assessment Report

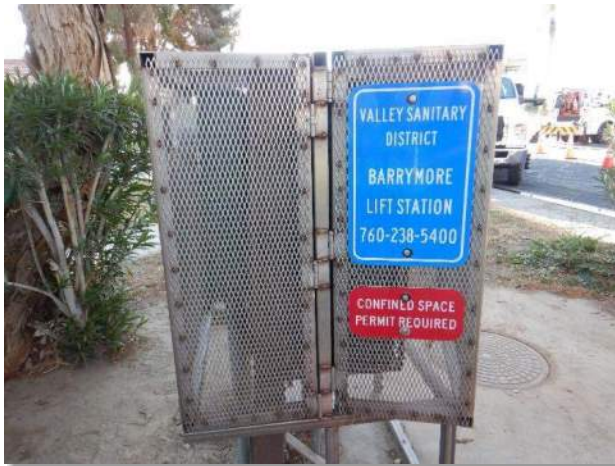
Photo 3-3. Barrymore LS control panel

The exterior concrete slab at the Barrymore LS was observed to be in fair overall condition with a large crack spanning in the northeast-southwest direction. The crack was approximately 0.60-inches wide and it was centered in the walkway between the wet well and dry well (VANDA 3). The exterior control panel at the site was found to be in good overall condition with minimal surface corrosion (VANDA 2). Refer to Photo 3-1 through Photo 3-4 below.

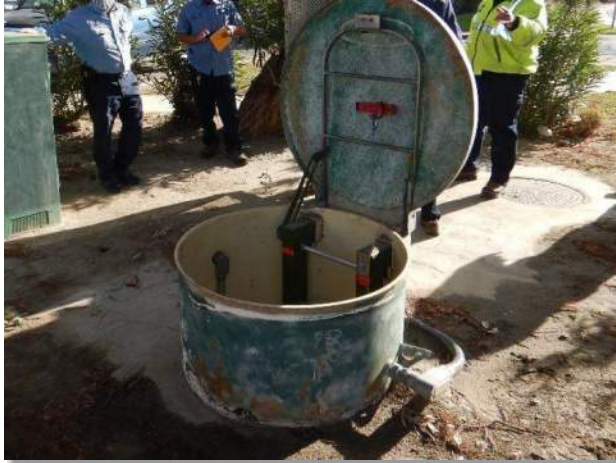
Photo 3-5. Dry well access hatch exterior

The exterior riser to the dry well was found to be in good overall condition, however, the exterior coating has become deteriorated (VANDA 2). The ladder entry system into the dry well was found to be in good condition with no defects noted (VANDA 1). The pumps, motors, and internal suction piping were found to be in good overall condition with minor wear on the coatings and surface corrosion typical throughout (VANDA 2). The discharge piping showed no signs of corrosion and minor wear was observed at the valve bolts and flanges (VANDA 1). The dry well floor plate and sump area, including the sump pump, showed moderate corrosion throughout with corrosion pits up to 0.07-in in depth at the slab (VANDA 3). Refer to Photo 3-5 through Photo 3-14 below.

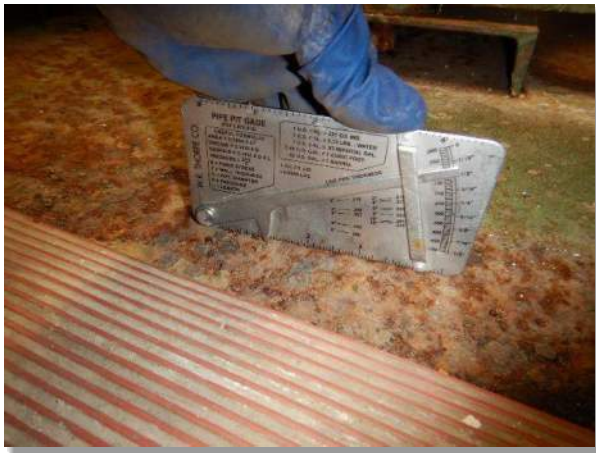
Photo 3-13. Moderate corrosion at floor plate, pits up to 0.07-in

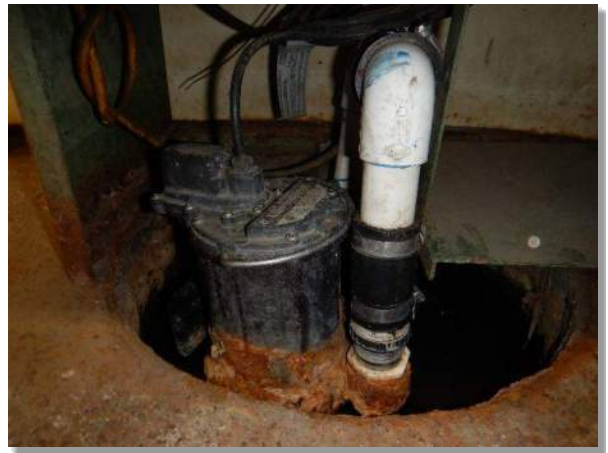
Photo 3-14. Moderate corrosion below waterline in sump area & sump pump

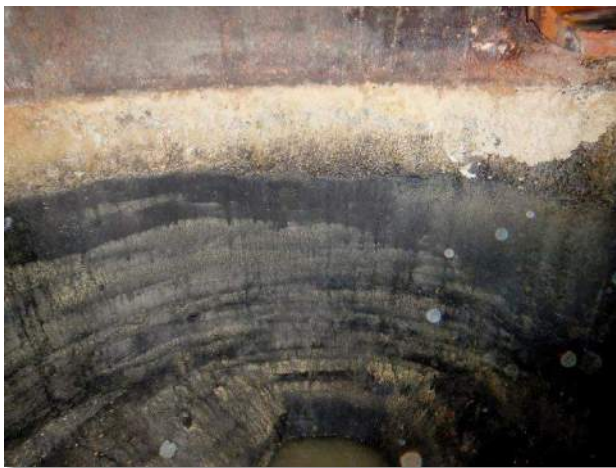
The frame for the wet well access cover was found to be severely corroded. According to Valley Sanitary operations staff, the manhole lid is close to falling in to the structure due to the metal loss of the rim (VANDA 4). The epoxy liner begins approximately 4-ft above the floor of the wet well and was found to be in fair overall condition with blistering (2-in in height) near the lower termination point of the wet well at approximate EL = 486-ft. There were also blisters at two locations approximately 6"x6" in area and located 4-ft below the rim in the east and west quadrants. Refer to Photo 3-15 through Photo 3-22 below.

Photo 3-19. Lower 4-ft of wet well unlined

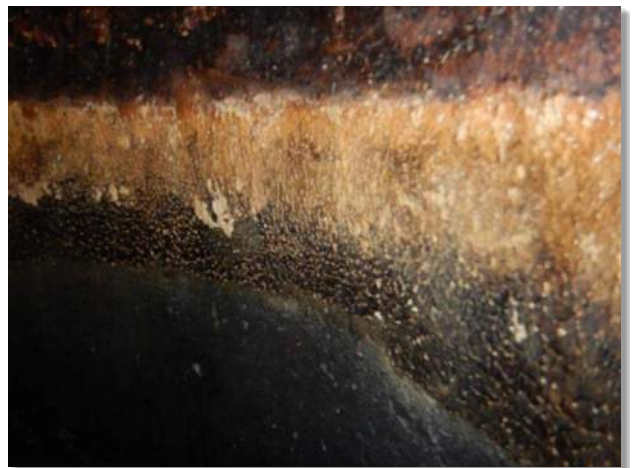
Photo 3-20. Blistering in liner (approximately 2-in) around circumference near lower termination point

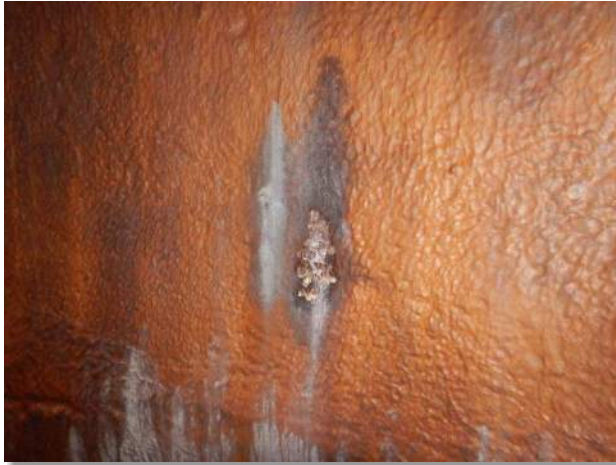
Photo 3-21. Blistering in liner, typical of 2 locations approximately 4-ft below the rim

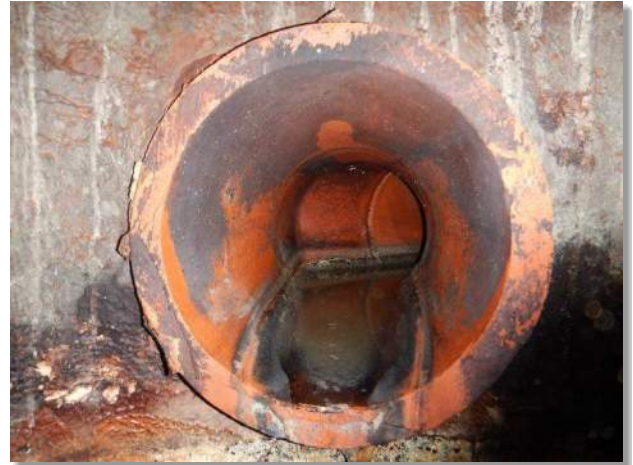
Photo 3-22. Wet well influent pipe

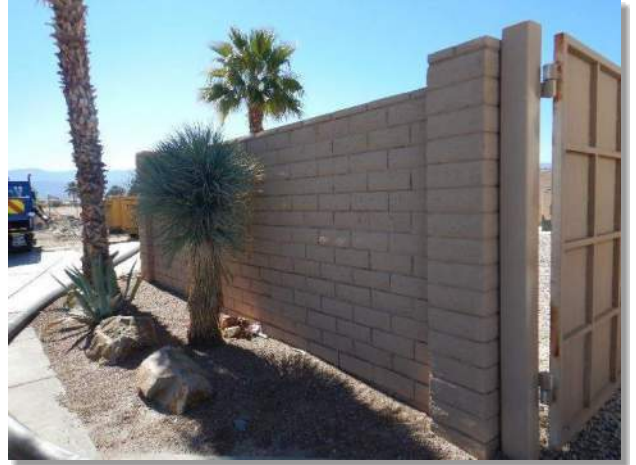
The access gate and CMU perimeter wall at the Calhoun LS were observed to be in good condition with no defects noted (VANDA 1). The CMU electrical building and the interior lift station control panel were found to be in good condition with no defects noted (VANDA 1). Coating deterioration was observed on the pad-mounted transformer along with minor corrosion (VANDA 2). Refer to Photo 3-23 through Photo 3-30 below.

Photo 3-24. CMU perimeter wall

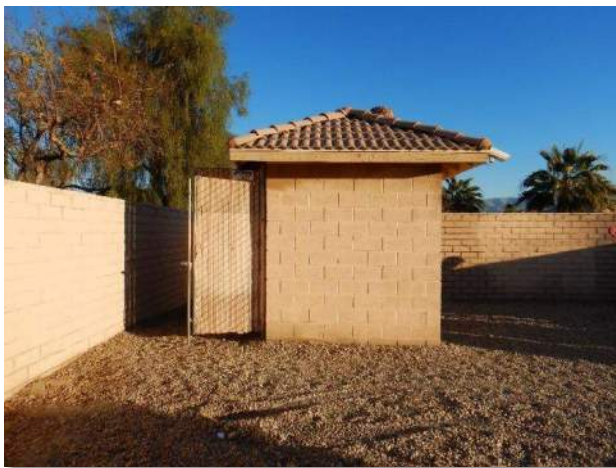
Photo 3-27. Electrical building exterior

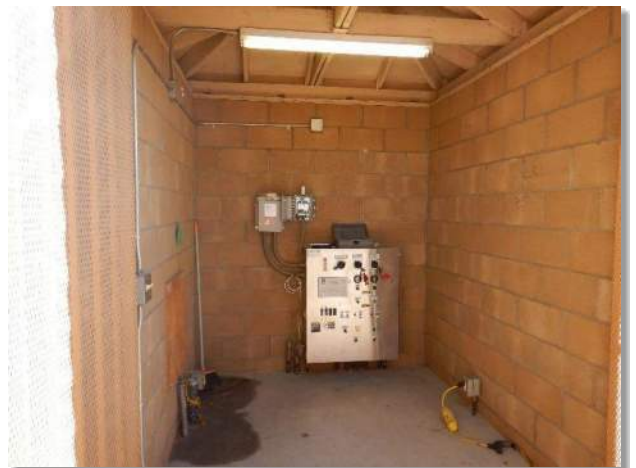
Photo 3-28. Electrical building interior

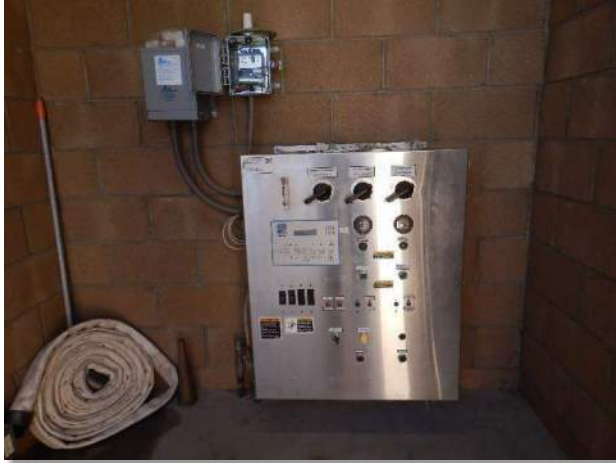
Photo 3-29. Lift station control panel

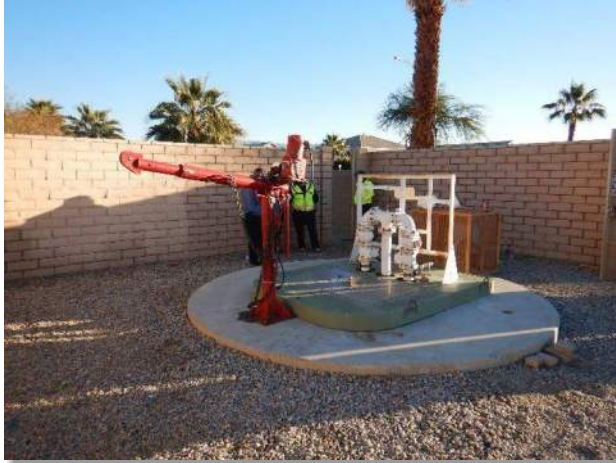
Photo 3-31. Wet well exterior

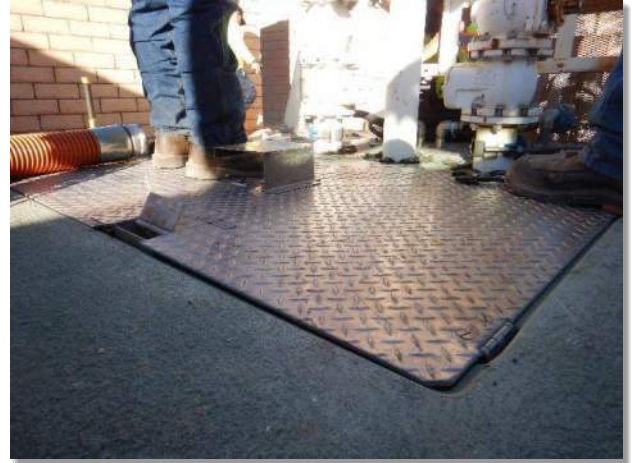
Photo 3-32. SST access hatch

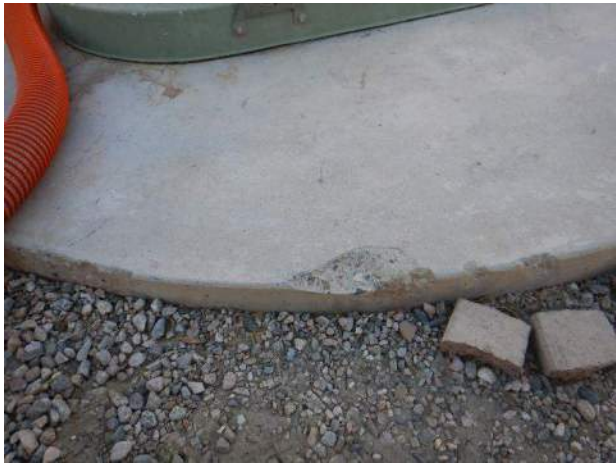
The stainless steel access hatch and fiber reinforced plastic (FRP) cover to the Calhoun LS wet well were found to be in good condition with no defects noted (VANDA 1). A spall was observed on the exterior of the wet well concrete pad, likely to be from impact damage (VANDA 2). The interior lining of the wet well has become delaminated throughout and was protruding approximately 1-ft from the wall, typical from the bottom of the wet well up to 6-ft below the ceiling. Approximately 10 to 15 tears were observed in the liner at each seam (seams spaced approximately 3-feet apart), with the average size of each tear approximately 6-inches W x 3-inches H.

Photo 3-33. Minor spalling on exterior concrete pad, likely due to impact damage

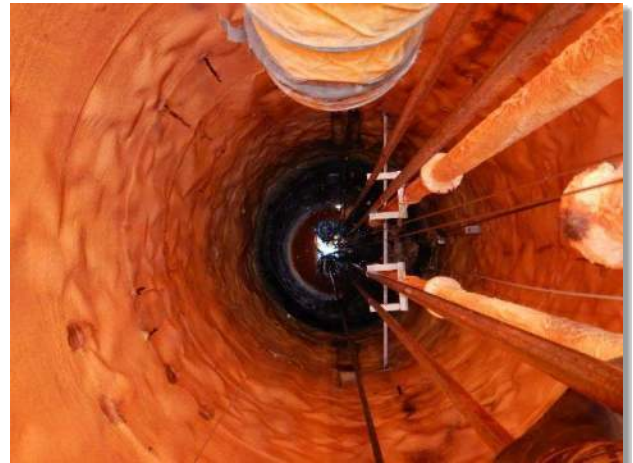
Photo 3-34. Wet well interior, topside

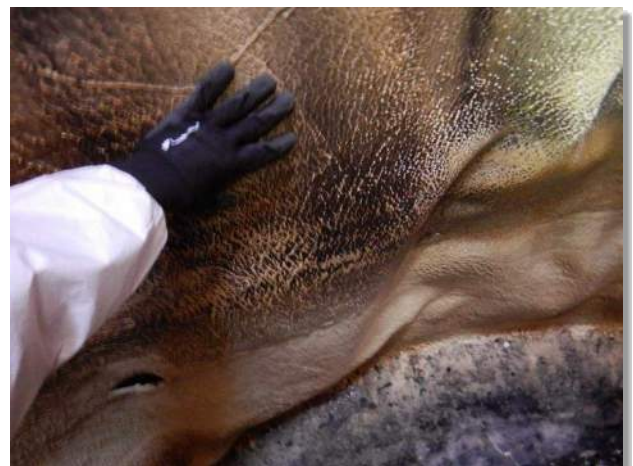
Photo 3-36. Severe delamination, closeup at lower section of wet well

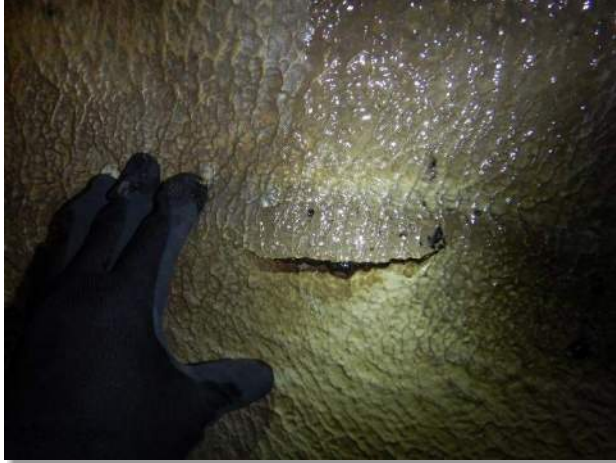
Photo 3-37. Tearing in liner, typical throughout

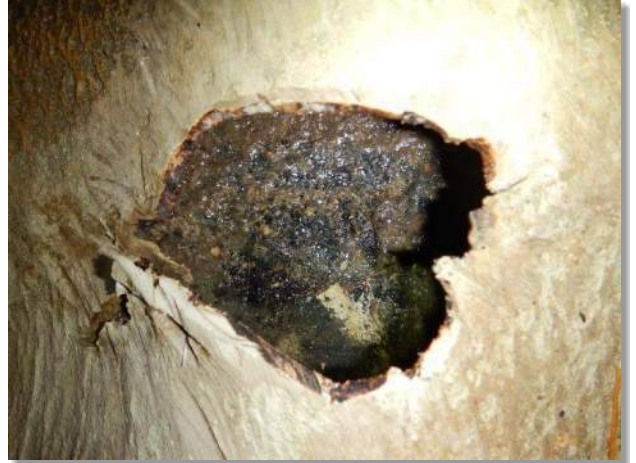
Photo 3-38. Close-up of concrete behind liner

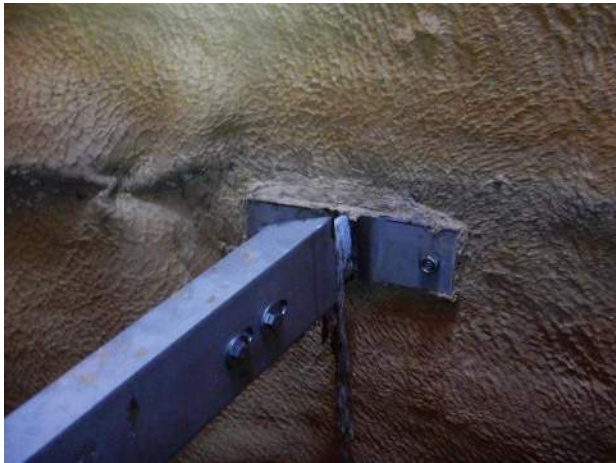
The stainless steel pump guide rails, supports, and hardware were found to be in good overall condition with minor corrosion staining (VANDA 2). Both of the submersible pumps were found to be in good condition with minor surface corrosion (VANDA 2). The interior pump discharge piping was epoxy coated (similar to the wet well lining) above the waterline, with only factory-coating in the lower 6-ft of the wet well; moderate corrosion was evident at several locations throughout both the epoxy coated and factory coated segments of the piping (VANDA 3). The aboveground pump discharge piping and header were found to be in fair condition with minor corrosion typical (VANDA 2). Refer to Photo 3-31 through Photo 3-52 below.

Photo 3-39. SST guide rail supports & hardware

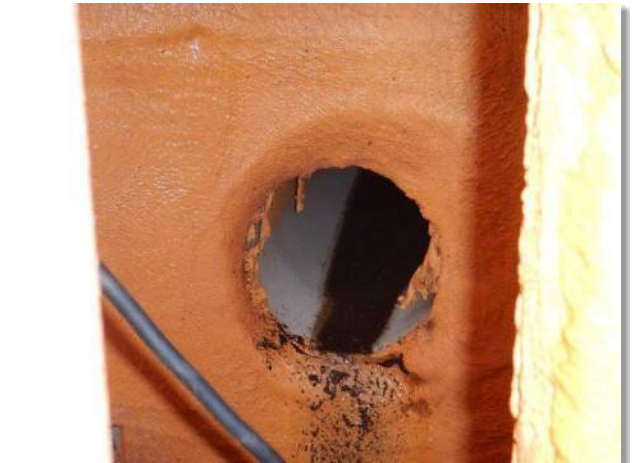
Photo 3-40. Emergency PVC overflow

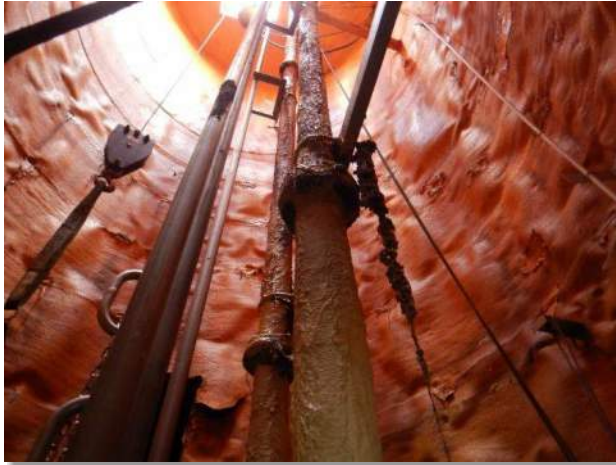
Photo 3-43. Epoxy coating on pump discharge piping above 6-ft

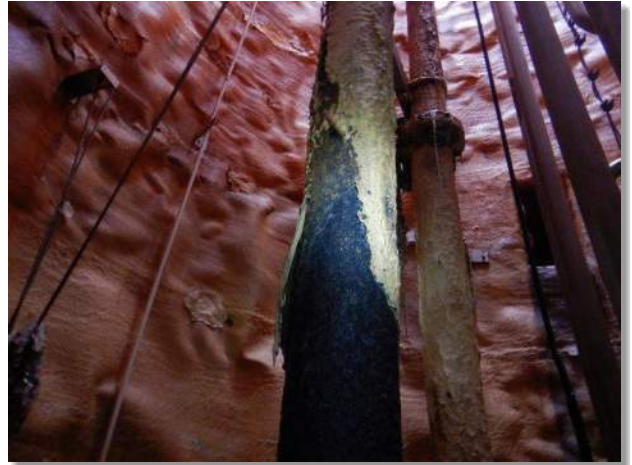
Photo 3-44. Epoxy coating begins at 6-ft from floor

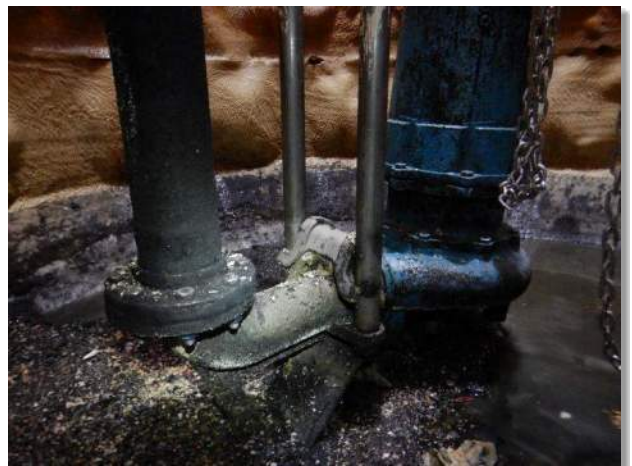
Photo 3-48. Pump 1 discharge piping

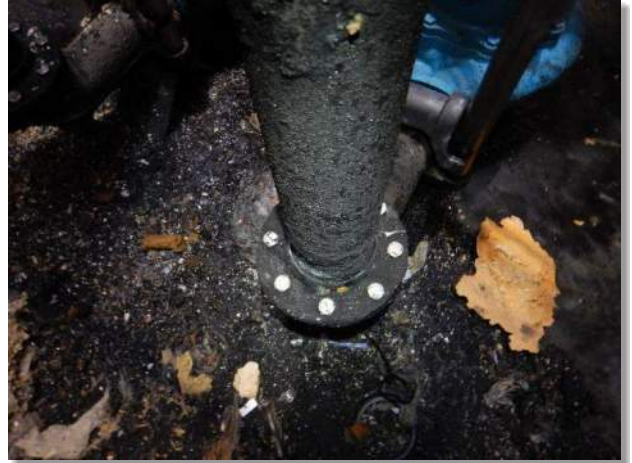
*Photo 3-50. Pump 2 discharge piping*

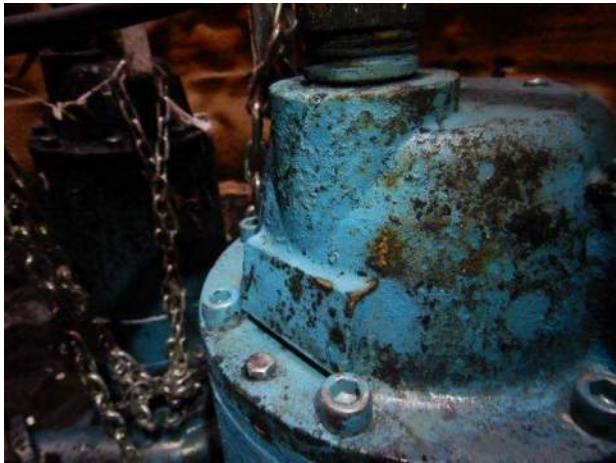
*Photo 3-51. Minor surface corrosion at Pump 2*

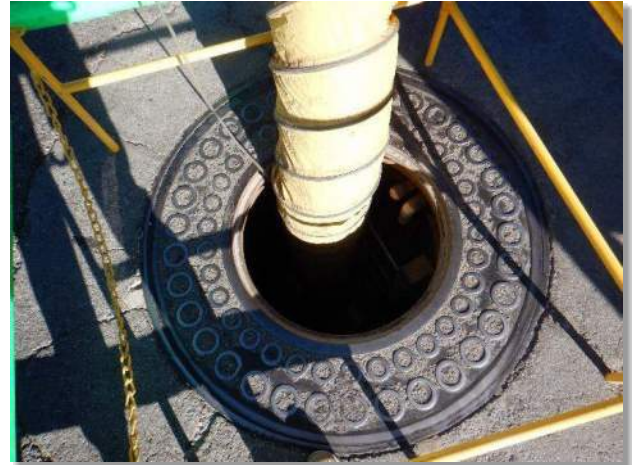
Photo 3-54. Dry well exterior framing

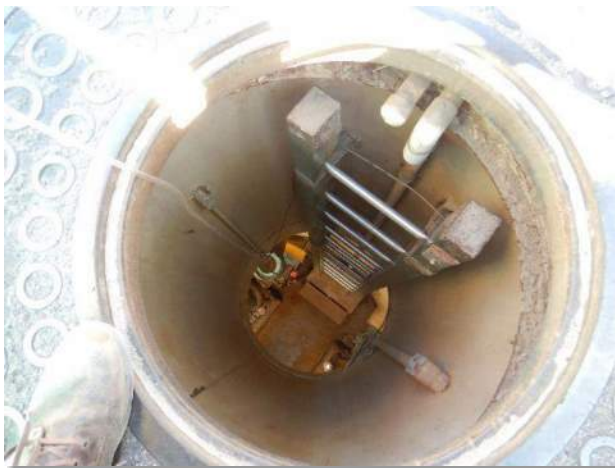
The framing for access into the dry well has a minor offset and moderate corrosion where the interior lining has delaminated (VANDA 3). The ladder entry system was found to have moderate corrosion at the interface with the dry well wall (VANDA 3). The pumps, motors, suction piping, and discharge piping within the dry well exhibited minor surface corrosion throughout (VANDA 2). The interior walls and ceiling of the dry well were found to have minor, localized corrosion where the coating has delaminated (VANDA 2). Moderate corrosion was observed throughout the floor plate with corrosion pits up to 0.150-inch, as well as at the sump and sump pump (VANDA 3). Refer to Photo 3-53 through Photo 3-70 below.

Photo 3-55. Dry well topside, minor offset in framing

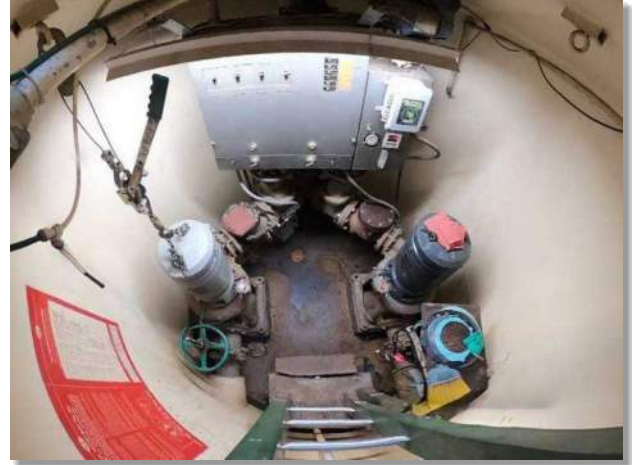
Photo 3-58. Dry well interior, 360 view (cropped)

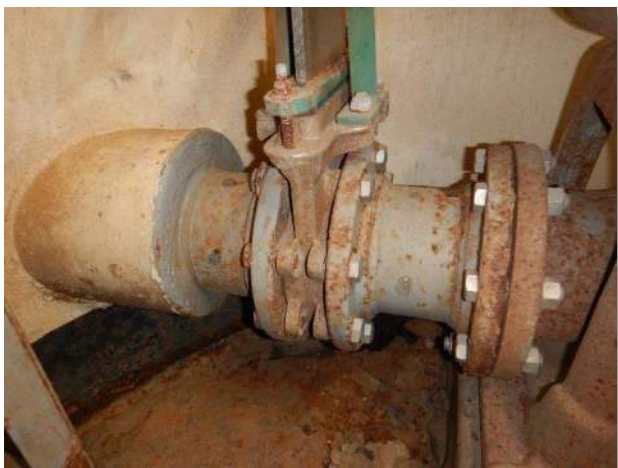
Photo 3-61. Pump No. 1 suction piping & valve

Location	No. of Meas.	Min. (mil)	Avg. (mil) <sub>(1)</sub>	Max. (mil)	Recommended Thickness (mils)
Pump 1 suction piping (upstream of Gate Valve)	9	10.8	21.7	34.8	8 to12
Pump 1 suction piping (downstream of Gate Valve)	10	2.4	2.9	3.9	8 to12
Pump 1	11	4.0	7.8	11.4	8 to12
Pump 2 suction piping (upstream of Gate Valve)	12	13.6	28.2	71.0	8 to12
Pump 2 suction piping (downstream of Gate Valve)	11	1.6	3.6	13.0	8 to12
Pump 2	15	0.1	3.5	13.6	8 to12
Discharge header	12	8.9	14.3	22.6	8 to12

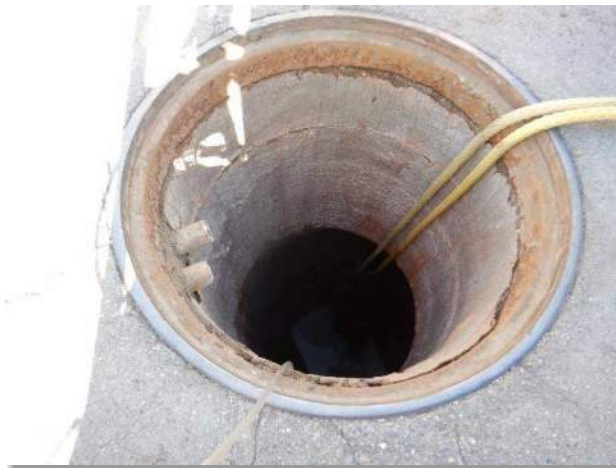
Photo 3-71. Wet well framing

The framing for access into the wet well exhibited moderate corrosion where the lining has deteriorated (VANDA 3). Otherwise, the interior lining was in good overall condition above the waterline, however, the liner beneath the laterals was torn and retaining water in multiple locations. Refer to Photo 3-71 through Photo 3-76 below.

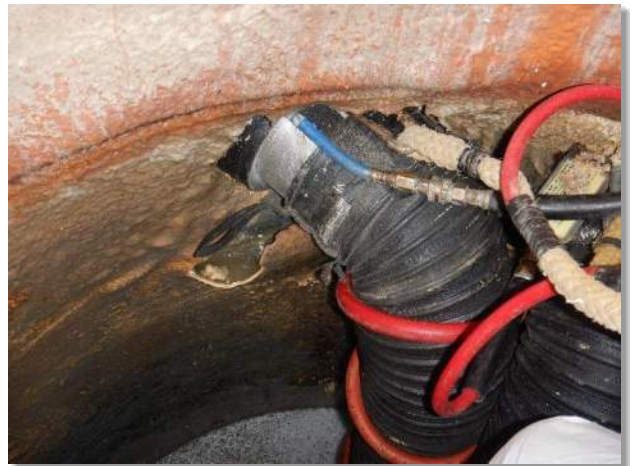
*Photo 3-76. Liner torn and retaining water beneath drop-in laterals*

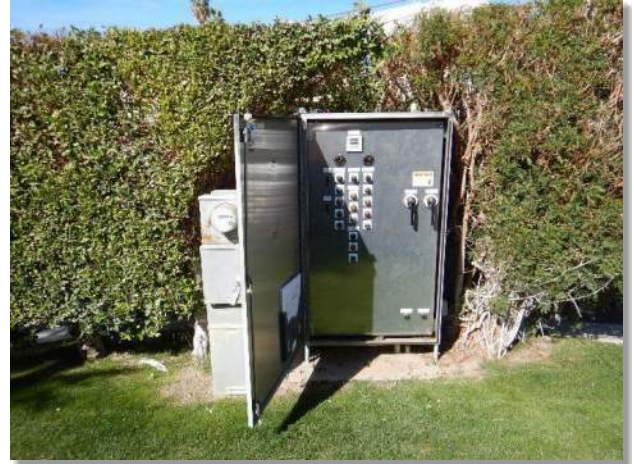
Photo 3-78. Pump control panel

The exterior of the wet well and vault at the Vandenberg LS are enveloped by a single concrete pad which was found to be in good condition with no defects noted (VANDA 1). The stainless steel motor control panel is located aboveground on a residential lawn and was found to be in good condition with no defects noted (VANDA 1). Refer to Photo 3-77 and Photo 3-78 below.

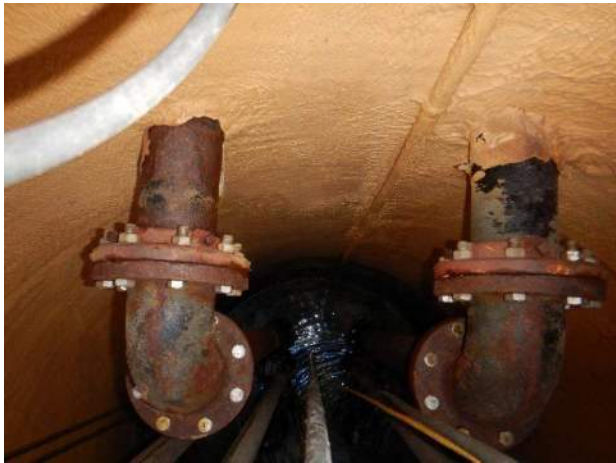
Photo 3-87. Moderate corrosion at elevated pump discharge piping
