**BOARD OF DIRECTORS  
SPECIAL SESSION  
AGENDA**

# LIFT STATION CONDITION ASSESSMENTS

## Lift Station Condition Assessment Report

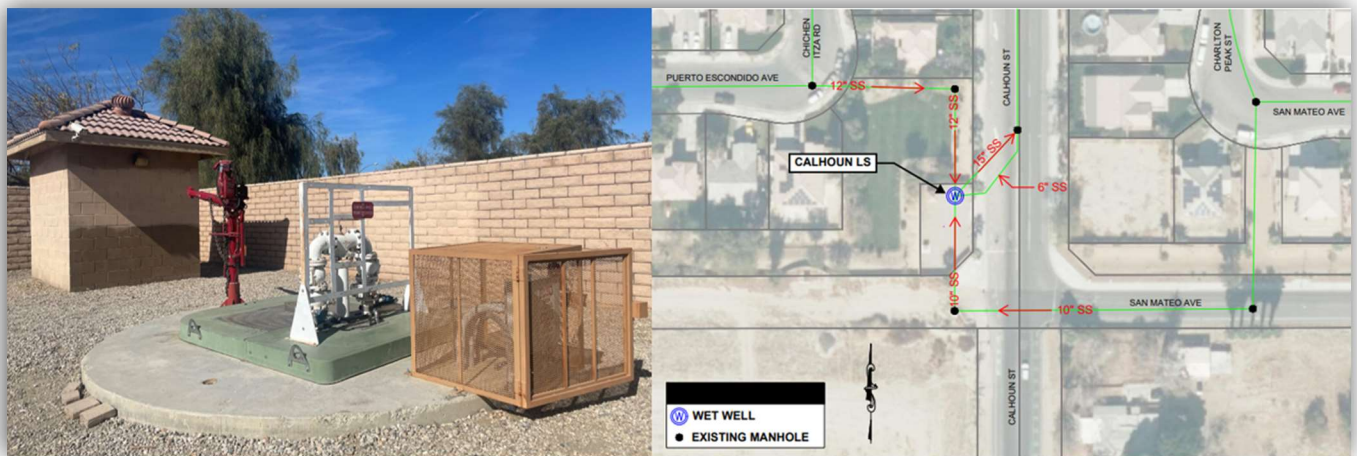
**FIGURE 2: Calhoun Lift Station Schematic and Site Photo**

The wet well collects flow from two incoming sewer mains and is then pumped through a 4-inch force main to a manhole in Calhoun Street. Provided drawings showed a 6-inch force main; however, from the site visits the visible piping was 4-inch. The station has two submersible pumps, each with a design capacity of 630 gpm and are operated in a duty/standby configuration. The wet well has a 15-inch PVC emergency overflow as shown on the drawings. The piping configuration is shown in Figure 2.

The Calhoun Lift Station was one of the lift stations needing the more immediate repairs. Specifically, the concrete liner protecting the concrete still well has deteriorated and needs to be replaced with a new protective liner. Other improvements include upgrade of electrical panel and control panel, install new sump termination panel, paint above ground pipe and fixtures, upgrade/replace lighting both within and exterior to the wet well, add SCADA capability and provide other improvements as listed in

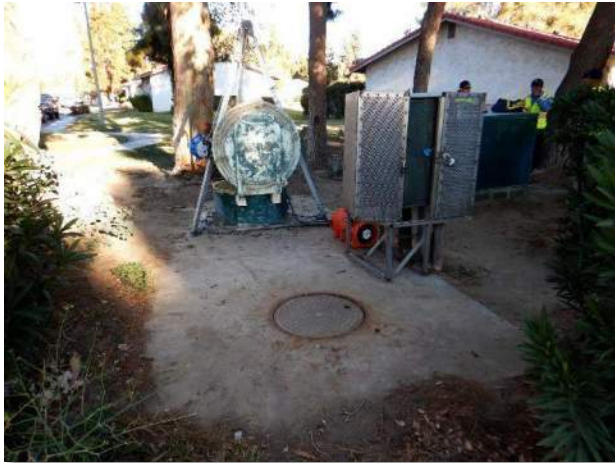
Photo 3-1. Barrymore LS site

The exterior concrete slab at the Barrymore LS was observed to be in fair overall condition with a large crack spanning in the northeast-southwest direction. The crack was approximately 0.60-inches wide and it was centered in the walkway between the wet well and dry well (VANDA 3). The exterior control panel at the site was found to be in good overall condition with minimal surface corrosion (VANDA 2). Refer to Photo 3-1 through Photo 3-4 below.

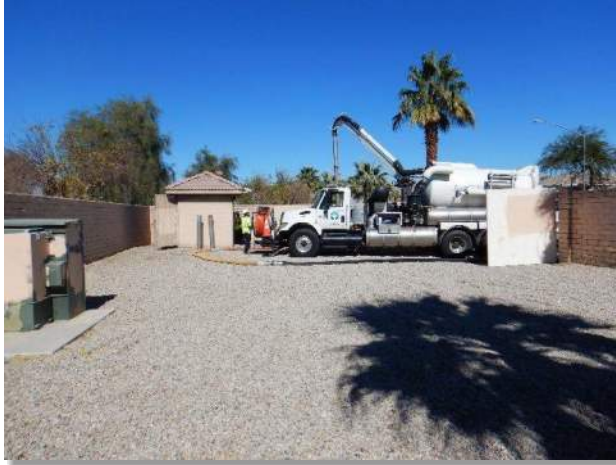
Photo 3-23. Calhoun LS site

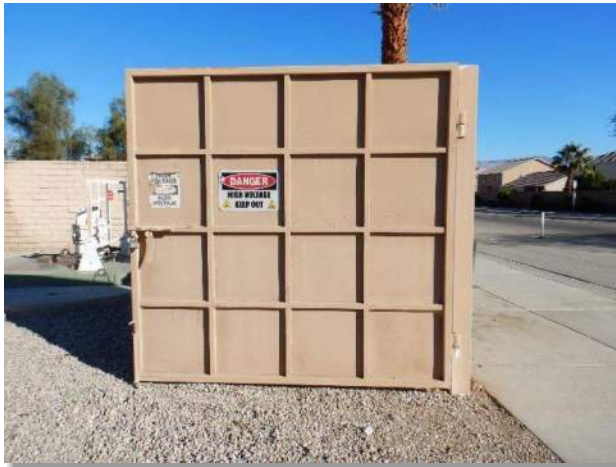
The access gate and CMU perimeter wall at the Calhoun LS were observed to be in good condition with no defects noted (VANDA 1). The CMU electrical building and the interior lift station control panel were found to be in good condition with no defects noted (VANDA 1). Coating deterioration was observed on the pad-mounted transformer along with minor corrosion (VANDA 2). Refer to Photo 3-23 through Photo 3-30 below.

Photo 3-25. Access gate

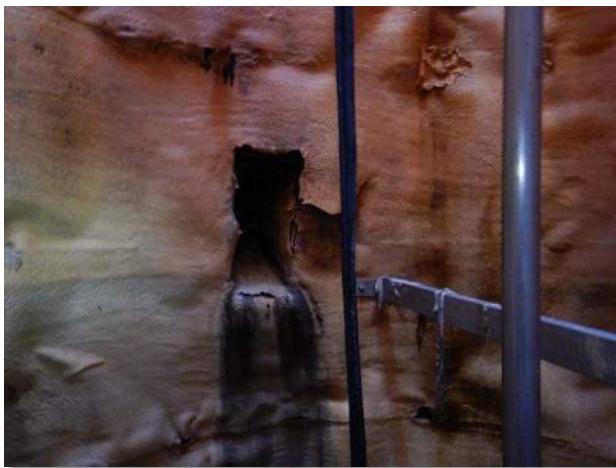
Photo 3-41. Influent from MH #5

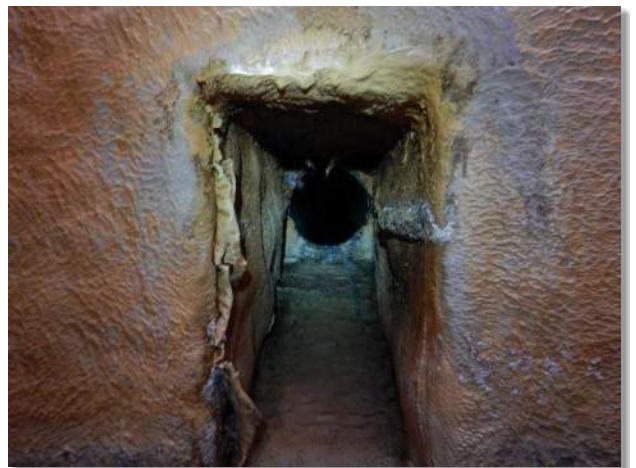
Photo 3-42. Influent from MH #7

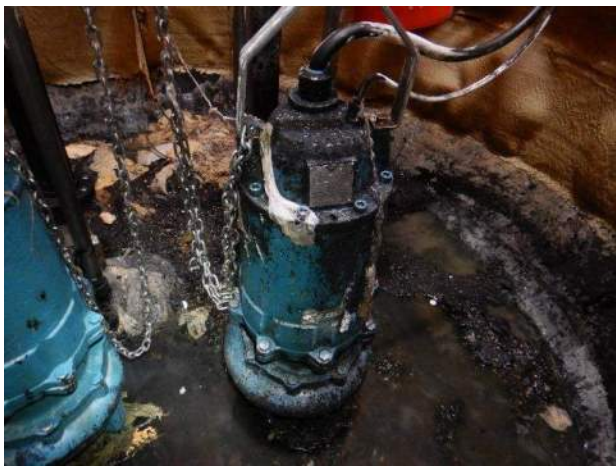
Photo 3-47. Pump 1 (south)

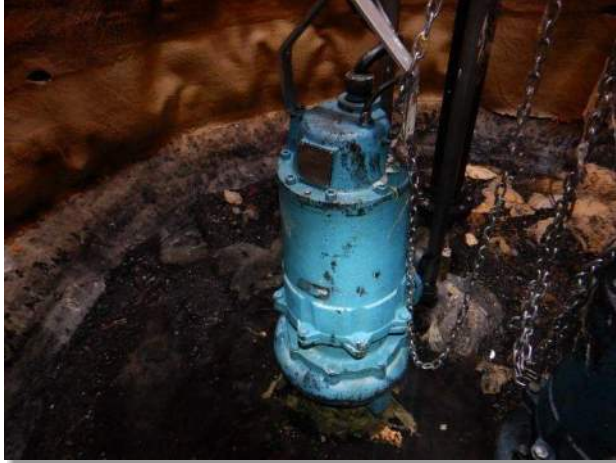
*Photo 3-49. Pump 2 (north)*

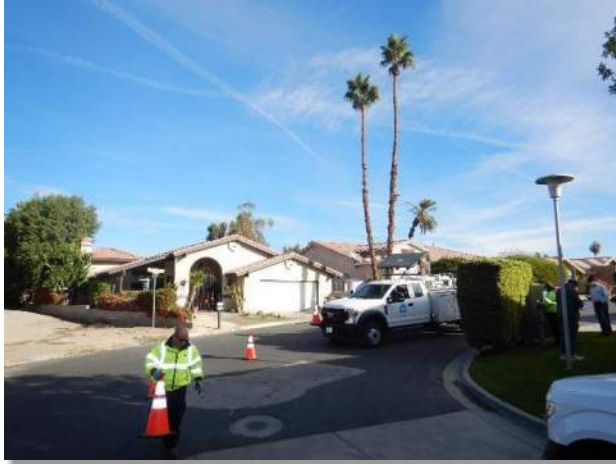
Photo 3-77. Vandenberg LS site

The exterior of the wet well and vault at the Vandenberg LS are enveloped by a single concrete pad which was found to be in good condition with no defects noted (VANDA 1). The stainless steel motor control panel is located aboveground on a residential lawn and was found to be in good condition with no defects noted (VANDA 1). Refer to Photo 3-77 and Photo 3-78 below.

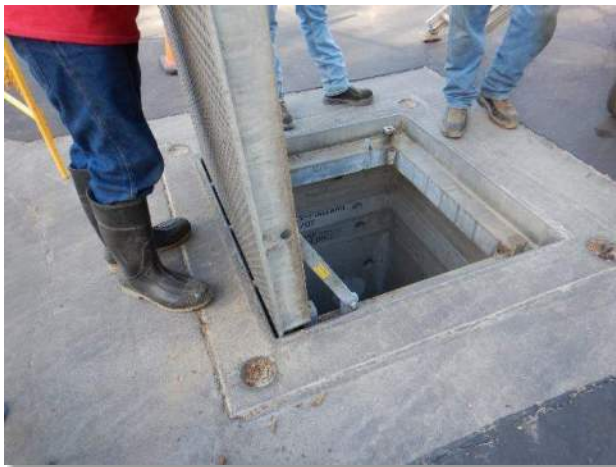
Photo 3-79. Vault exterior

The access hatch to the valve vault at the Vandenberg LS was found to be in good condition with no defects noted (VANDA 1). The interior surface of the pre-cast structure including the walls, floor, ceiling, and interior discharge piping and valves were also found to be in good condition with no defects noted (VANDA 1). Refer to Photo 3-79 and Photo 3-80 below.
